SHRINK FIT APPLICATIONS

Customer: KNPC

Shuaibah Refinery
Kuwait

9th to 11th July 2008

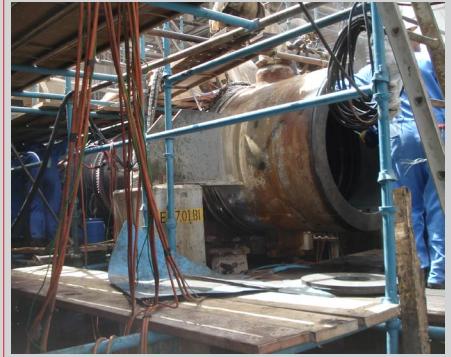
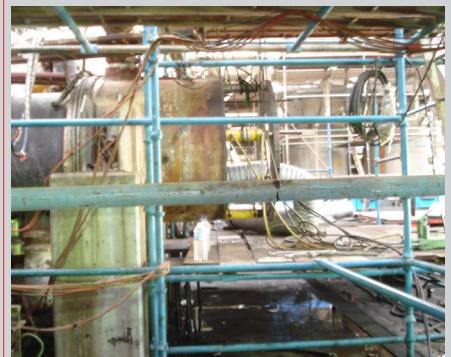
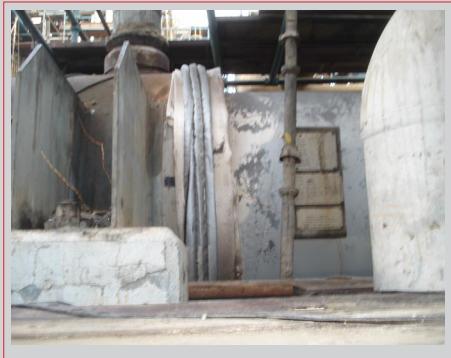
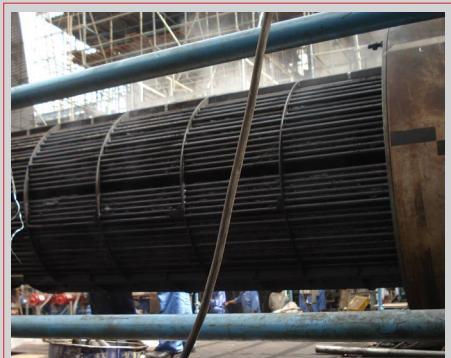
We set up a four coils configuration positioned directly on the outer shell adjacent to the internal tube plate and heated as instructed by KNPC Engineers. Heating range: from ambient to 700F. KNPC used various methods, including tube pulley and a 60ton crane to pull the tube plate and extract the tube bundle from the heat exchanger. The bundle was removed approximately 30 hours after first heating.

This vessel proved to be more stuck than the first. After many hours of trying unsuccessfully to pull the tube plate out using the same methods as the first vessel, we were allowed to apply our method of extraction. We first attached the tube extraction plate via four extended rods to the tube plate between the outershell and the tube plate. Between the outershell and the tube extraction plate we fitted 4 off 30ton hydraulic jacks. These jacks were then pressurised to lock in position. We cooled the tube plate to approx 108F by spraying with soda water. Next we attached air conditioning to the tube plate to help keep it cool again. Via four coils positioned directly on the outershell adjacent to the internal tube plate we heated the outershell to 450F. Whilst still heating we instructed the jacks to be pressurised more. As the heat increased the tube plate popped out. Time taken approx 4 hours.
